Landslide Monitoring and Frequency – Towards real-time Landslide Risk Management

University of Wollongong

Phil Flentje - Senior Research Fellow - Faculty of Engineering

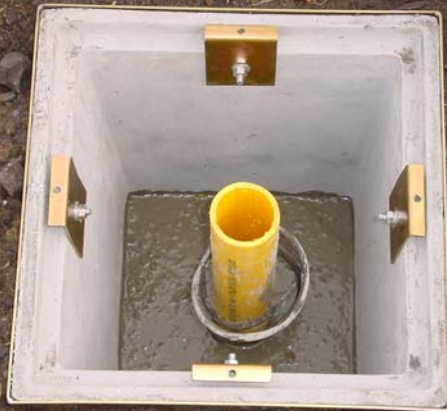
Casing installed

- Consist of casing grouted into borehole, and inclinometer probe to record profile along casing (typically installed vertically)
- Used primarily to measure the depth to and style of subsurface shear movement
- With time, they continue to record this but they also record the rate of movement
- We have and continue to monitor 25 inclinometers across the city, some periodically, but some continuously
